Supplementary material

Procedure images for case 2. aa) suspicious malpositioning of transpedicular screws in L4 and L5 by AP plain radiograph (white arrow); ab) medial perforation of screw in L4 (white arrow) by CT scanning; ac) medial perforation of screw in L5 by CT scanning (white arrow).

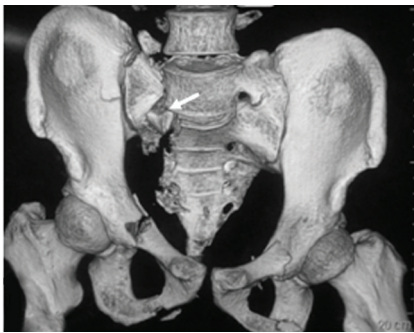
Fig. ba

Procedure images for case four. ba) comminuted fracture of right sacrum by CT scanning (white arrow); bb) suspicious malpositioning of transpedicular screw in the sacral canal by AP plain radiograph (white arrow); bc) misplaced screw in the spinal canal by CT scanning.
